NATIONAL BUREAU OF STANDARDS REPORT

REPORT ON THE PERFORMANCE OF
ASBESTOS FIBER-BASE BUILT-UP ROOFS

7 February 1969

Thomas H. Boone and Leopold F. Skoda

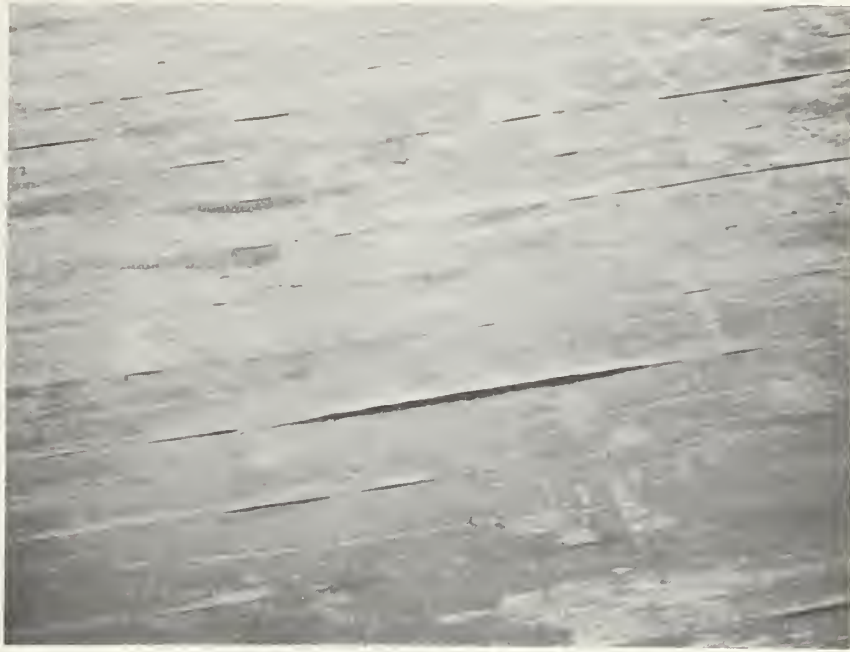
FIGURE 2. Delamination of asbestos felt
on smooth built-up roof.

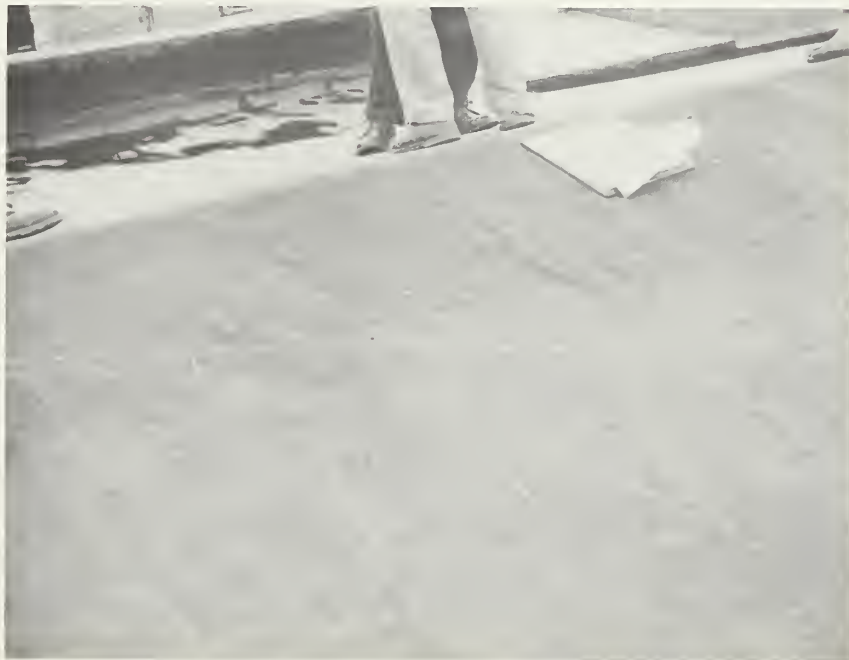
3. Between-ply blistering appeared either to be caused by inadequate application of bitumen or moisture conditions prevalent at time of construction of membrane. Most membranes exhibited excellent interply adhesion.

FIGURE 3. Blister caused by poor interply
adhesion.

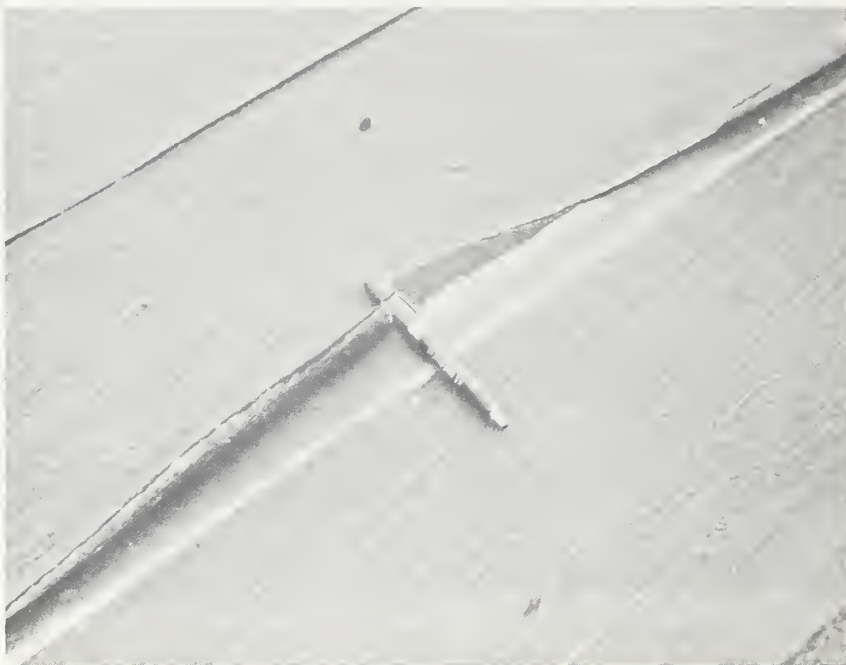
21	18	No leaks	Numerous blisters	Excellent bond between plies
22	13	No leaks	Extensive blisters	Excellent bond between plies
23	10	Subjected to several hurricanes, No leaks	Coating on south exposure worn off, Some felt torn	Excellent bond between plies
24	15	History of leaks	Roof covered with mineral cap sheet, Few large splits	Splits through complete membrane
25	15	Subjected to several hurricanes, No leaks	Coating worn off, Felts at laps delaminated & torn (see Fig. 8)	Excellent bond between plies

Figure 8. Asbestos felts delaminated and torn. This roof was subjected to several hurricanes.
